# NATIONAL TRANSPORTATION SAFETY BOARD

## PIPELINE ACCIDENT REPORT

NATURAL GAS EXPLOSION AND FIRE  
DEPARTMENT OF DEFENSE/ARMY  
FORT BENJAMIN HARRISON  
INDIANAPOLIS, INDIANA  
DECEMBER 9, 1990

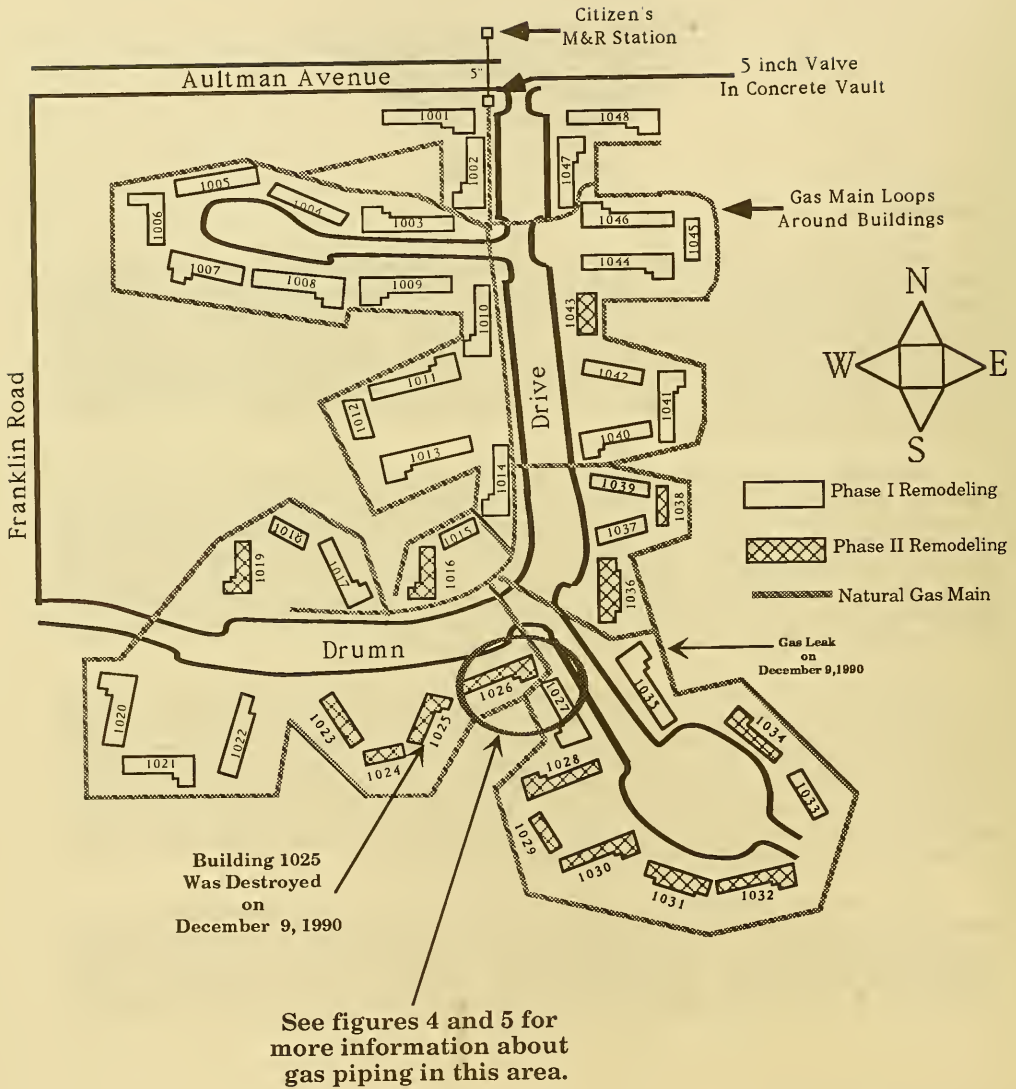
Figure 1.--Schematic of Harrison Village, Fort Benjamin Harrison.

At 5:42 p.m. on December 9, 1990, an occupant of Harrison Village<sup>1</sup> (village), a residential housing complex within the Army's Fort Benjamin Harrison (Fort) near Indianapolis, Indiana, telephoned the Fort's fire department to report the odor of natural gas behind apartment 1035 B on Drumn Drive. (See figure 1.) The Fort's fire department dispatched firefighters, including the assistant fire chief, who served as the incident commander. They arrived at 5:47 p.m. and using a combustible gas indicator, confirmed the presence of gas both outside and inside some of the five apartments in building 1035.
